Inspection Report

Minerals Regulatory Program

Mine Name: Torrey Red Quarries	Permit Number: S0550021
Operator Name: State Stone Corp Inc.	Inspection Date: April 19, 2011 April 20, 2011
Inspector(s): Wayne Western	Time: 5:00 – 5:15 PM on April 19, 2011 4:00 – 4:20 PM on April 20, 2011
Other Participants:	Mine Status: Active

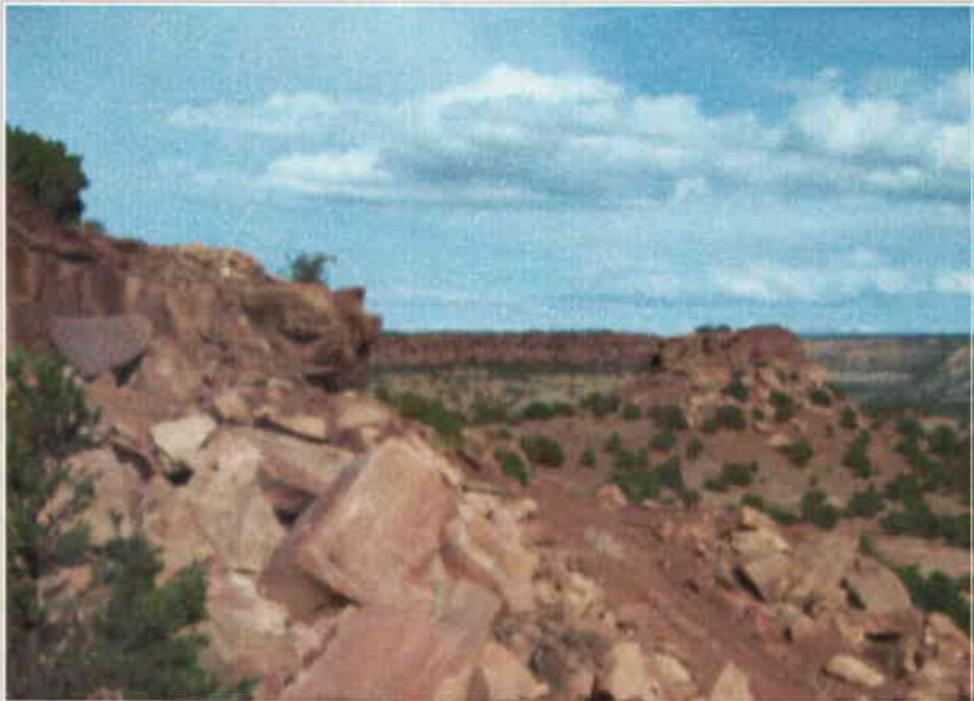
There was what appeared to be drilling and blasting of the bedrock. Roads were constructed to get to the top of the ridges/outcrops.

Road leading to quarry east side

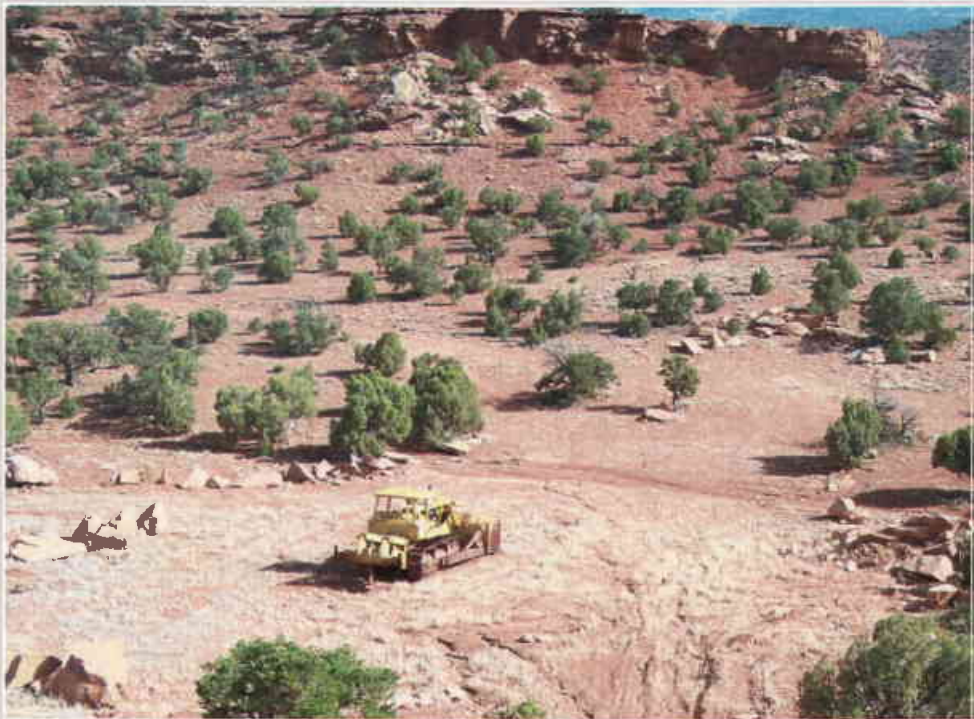
East Side Pit: The site appeared stable. There was no sign of recent activities on the east side pit. Some minor rills were observed, but none appeared to go off site.

Overview of equipment storage area east pit.

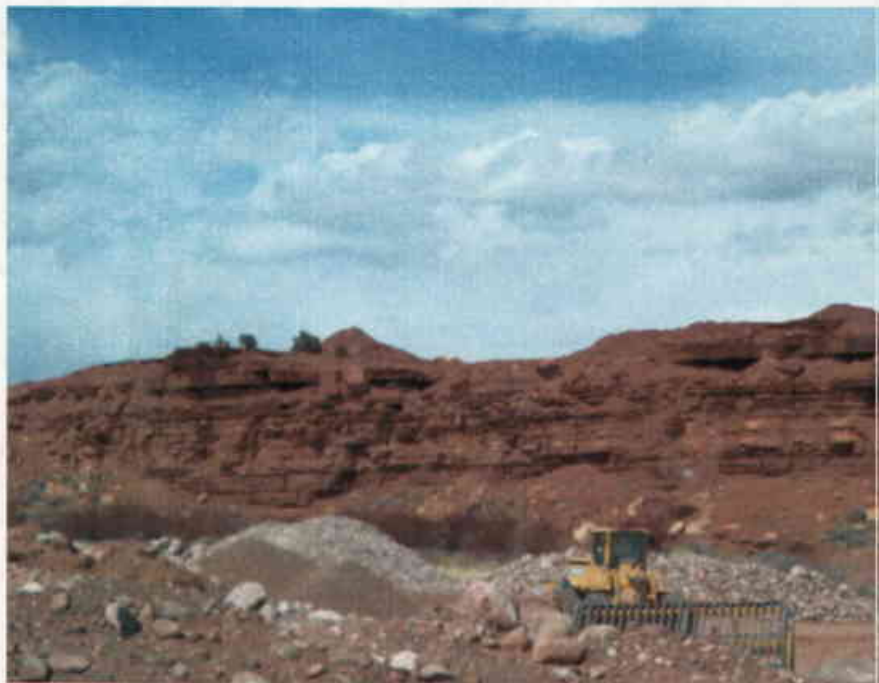
West Side Pit: The pit was active at time of inspection. The Operator was screening materials. The site was stable.

Stockpiles and equipment west pit

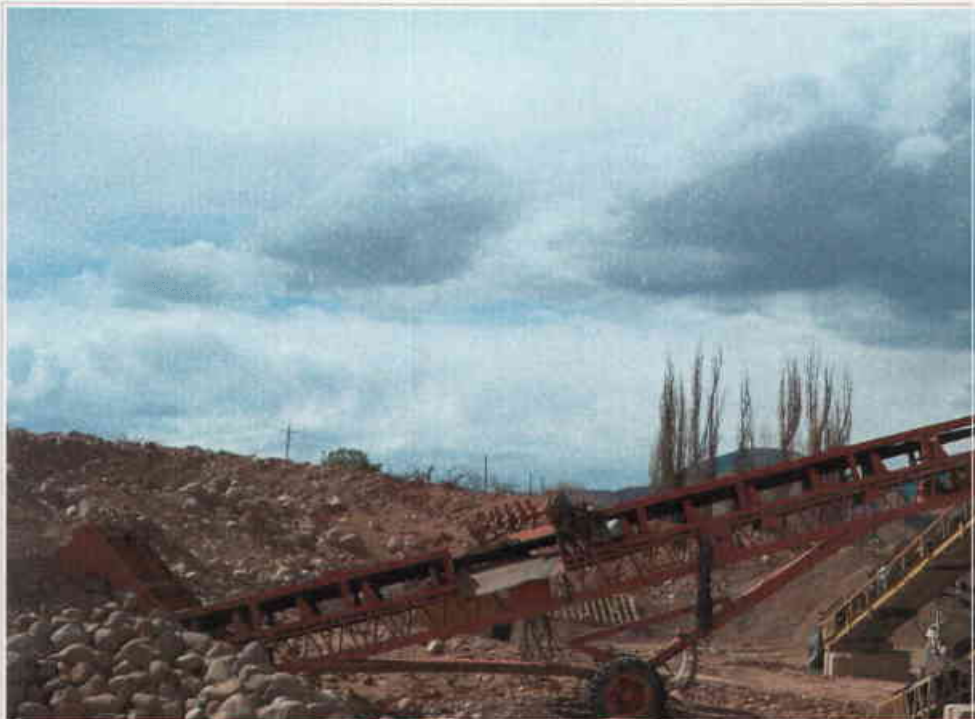
Screening equipment west pit
